## Variation and lake expansion of Chubda Glacier, Bhutan Himalayas, during the last 35 years

### Abstract

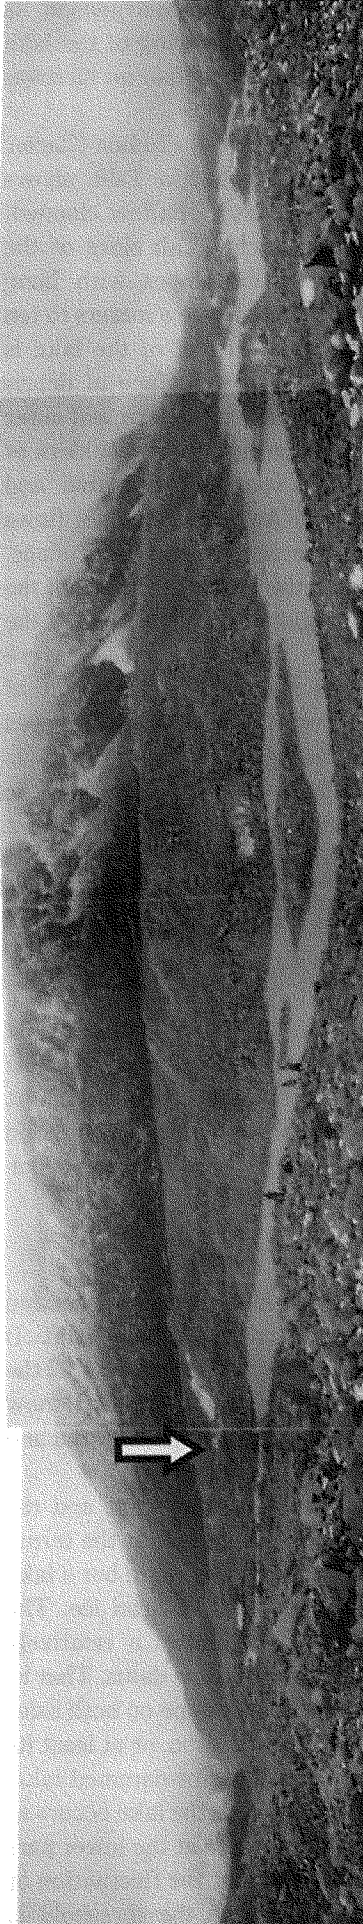
Fig. 3. View from the left bank of the lower part of Chubda Tsho. The flat terminal threshold forms the outlet of the lake water (left). Small islands are distributed in the lower reaches of the lake (center and right). The fresh supraglacial debris-mantled slope borders on sparsely vegetated Holocene/Little Ice Age moraines (far back of center) with a clear boundary. The white arrow indicates the location of Figure. 4. Photo taken on September 26, 2002.

Chubda Glacier is a compound glacier with a rectilinear-shaped tributary glacier (GC 4-1, coded by Karma *et al.*, 1999) that stretches down from the north-northeast and joins a crank-shaped main glacier (GC 4-2) that stretches down from the northeast (Fig. 2). The upstream part is the debris-free glacier, while the lower part is covered with a thin debris mantle. The glacier ice is exposed in the faces of small cliffs in the downstream part of the right bank of the glacier (Fig. 3) with a thin covering of surface-debris 0.5–1.0 m in thickness (Fig. 4). The debris in the debris-covered area which were observed by the field investigation, are comprised of light-gray fresh granitic and gneiss boulders with no plant or lichen cover. The debris-covered area could be identified on SPOT images as a light gray area, with distinct borders from the surrounding area composed of dark-colored basement rocks and older moraines. Chubda Tsho occupies the central part of the debris-covered area, which is a nearly flat glacier tongue with some hummocky hills (Figs. 3 and 5). The glacial front of Chubda Glacier forms a steep slope covered with surface debris.

The furthest downstream part of Chubda Glacier that functions as threshold of Chubda Tsho shows very complicated features. It has a shallow channel-like water area with many inlets. Both sides of the lake have gentle debris-mantled slopes with hummocky hills ranging in height from a few meters to ten meters (Figs. 3 and 5). The lower end of the lake is bounded by an almost flat narrow surface of debris mantle. This flat surface bounds on the terminal outer slope. Figure 8 shows that the light-gray boulders of the outer side overlie the sparsely vegetated and dark-colored older moraine. An outlet channel flows on the flat surface and stretches to the outer slope. The outlet water seeps into the debris at the end of the flat surface, and emerges again at the lower end of the terminal slope. Shallow debris channels were identified on the terminal slope below the point of disappearance, and the channel beds were composed of unstable and slippery boulders. The sound of submerged water flow could clearly be heard beneath the boulders in the dry channel. The emergence point corresponds to the boundary of the present glacier and the older moraine (Fig. 8). Karma *et al.* (1999) reported the continuous surface flow on the terminal slope in summer, 1999. The difference in the outlet flow between 1999 and 2002 may be due to differences in the outlet discharge amount. Two alluvial cones exist at the lower end of the terminal slope (Fig. 8). The riverbed debris from these alluvial cones was most likely transported by outlet flows from the lake and mass movement, such as debris flow and small collapse due to failures of the threshold.

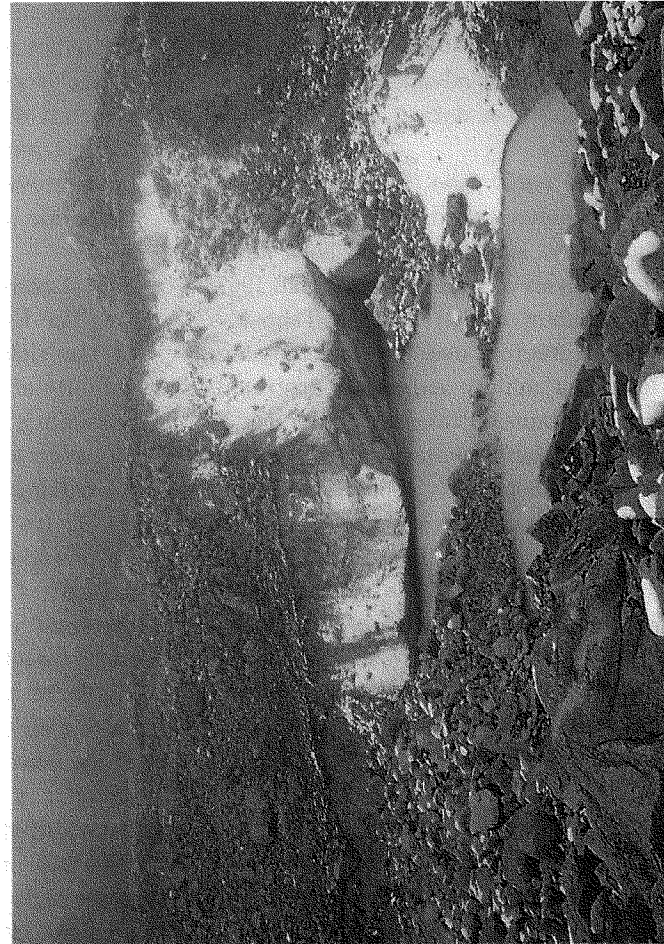
Fig. 4. Ice core exposed below the supraglacial debris 0.5 - 1.0 m in thickness. The location is indicated by the white arrow in Figure 3. Photo taken on September 26, 2002.

gravitationally stable under current condition, the existence of past collapse scars on the terminal slope and ice core remaining in the terminus suggest that there is a potential danger of threshold failure.
